CASE STUDY

One of these is a residential-commercial building called York Beach Residence Club. Built in 2016, this 4-story 25-unit multiuse facility includes condo units, shops, restaurants and a hotel. Because of the seasonal nature of the location, it's construction was highly time-sensitive.

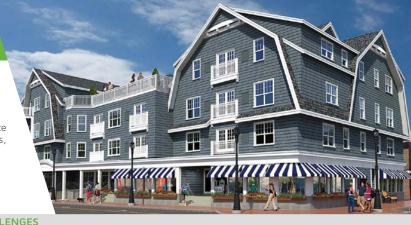
The original plan called for plated trusses to be used for the floor structures.
