TYPICAL DETAIL REPAIR METHOD FOR A NOTCHED 2x3 OR 2x4 TOP CHORD, LESS THAN HALF THE WIDTH, WITH A PIPE

RTF-006-18

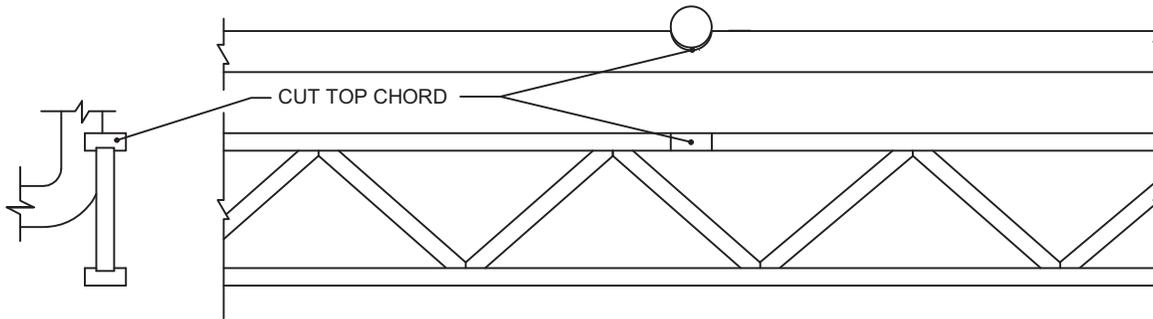
SITUATION BEFORE REPAIR

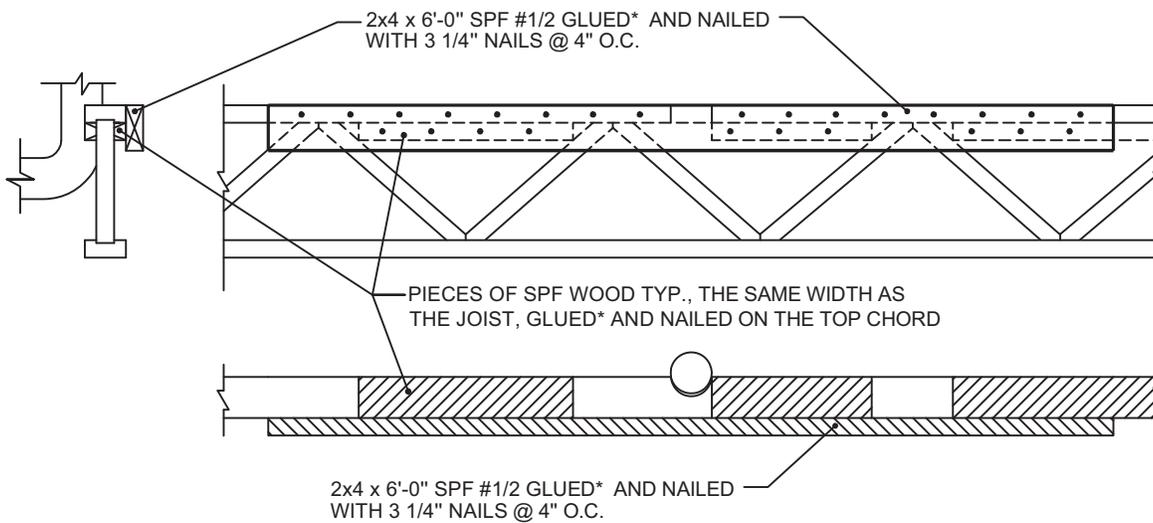
SITUATION AFTER REPAIR

*PL PREMIUM GLUE
